Turkey-Syria Quake: Why So Many Buildings Collapsed

Turkey earthquake: Why did so many buildings collapse?

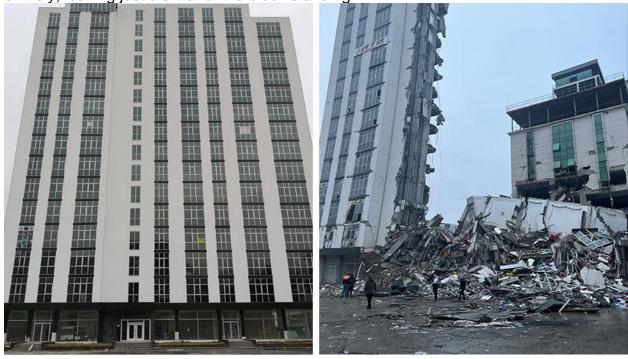
Photographs show that another recently built apartment block in the port city of Iskenderun was largely destroyed. The side and rear of the 16-storey building collapsed

entirely, leaving just a sliver of the block standing.

The BBC matched the image of the collapsed building to a publicity photo published by the construction company, which shows that it was completed in 2019.

That means it should also have been built to the latest standards. The BBC has contacted the construction company responsible, but has received no response.

Photos above: A recently built apartment block in Iskenderun, before and after the quake. Source: BBC. Image on this page: Designs of Japanese earthquake-adapted construction techniques. Source: Japan Property Central.
