**SUR – The Walled City of Diyarbakir
Conflict, Dispossession and Destruction
Damage Assessment Report**

1 August 2017

DAMAGE ASSESSMENT REPORT

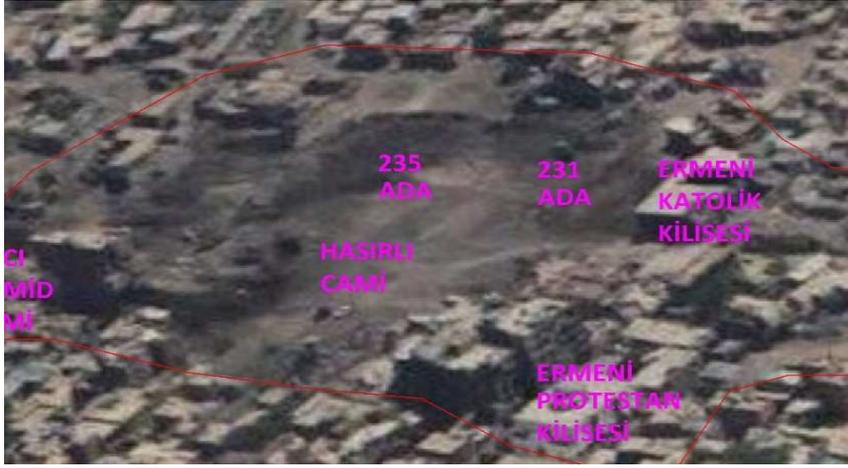
Photo. 2: From aerial photographs it may be seen that Hasırlı Cami, located at parcel no 235/19 has been completely destroyed and the debris removed, without a trace left in its place.

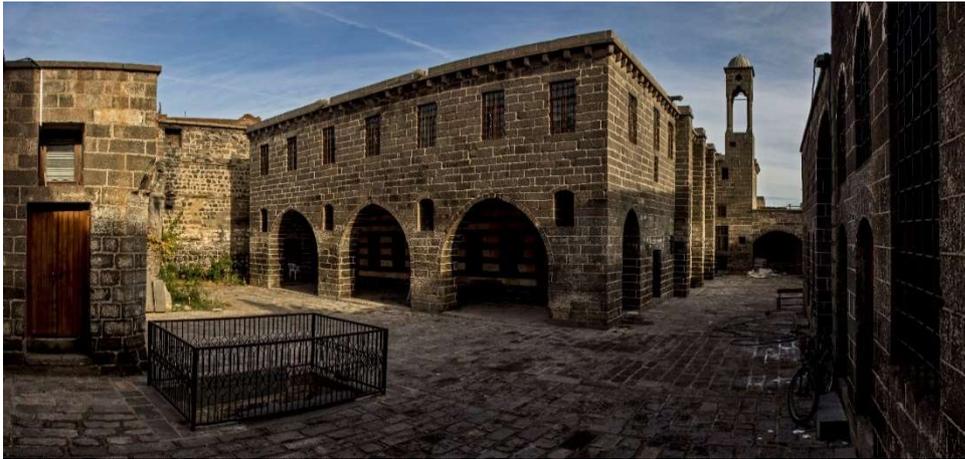
Photo. 3:
After the restoration in 2014

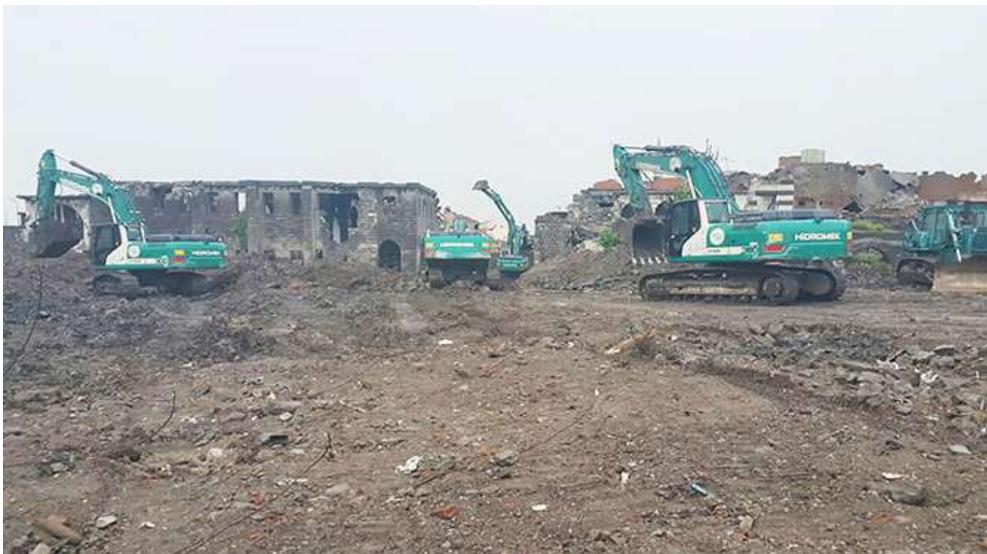
The bell tower, south courtyard wall, main entrance door, the courtyard located to the west of the church and the church outbuilding of the Armenian Catholic Church, another important registered structure, are completely destroyed and a wide road has been opened in this area. (see below)

Photo. 4:
March 2016
The destruction resulting from razing a road through the church.

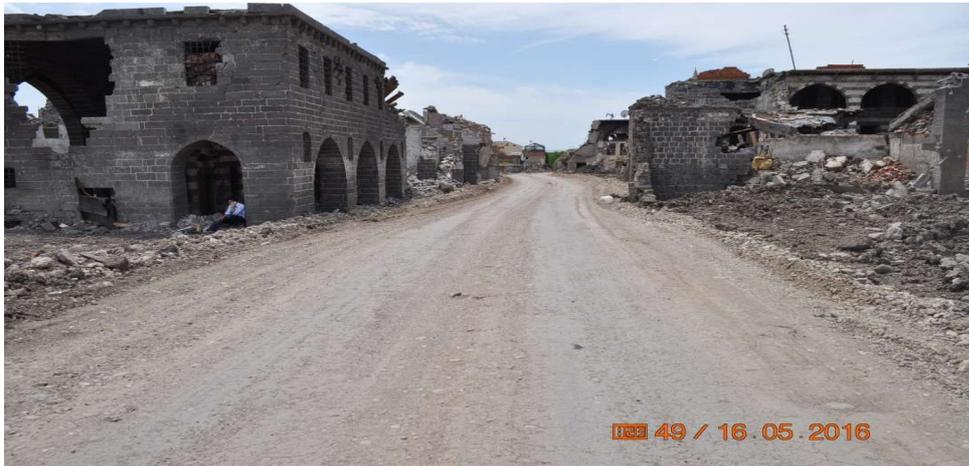
Photo. 5: 16 May 2016, another view of the Armenian Catholic Church after part of it has been taken up by the road.

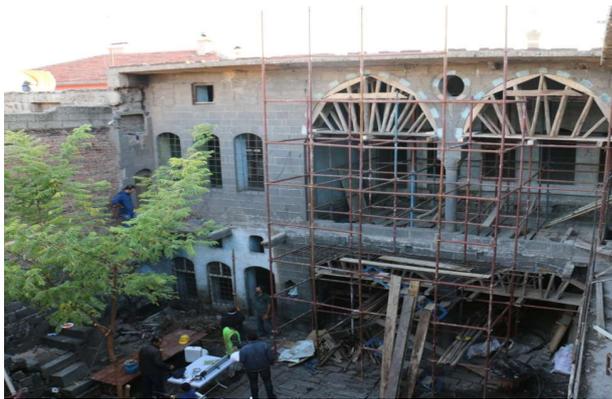
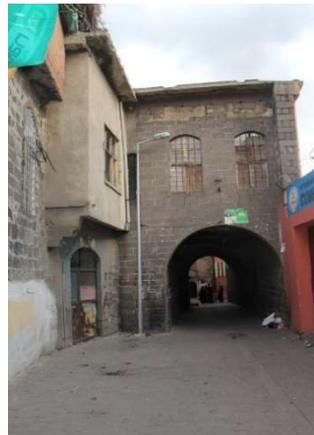
Photo. 6: Restoration works before the demolition, 2015

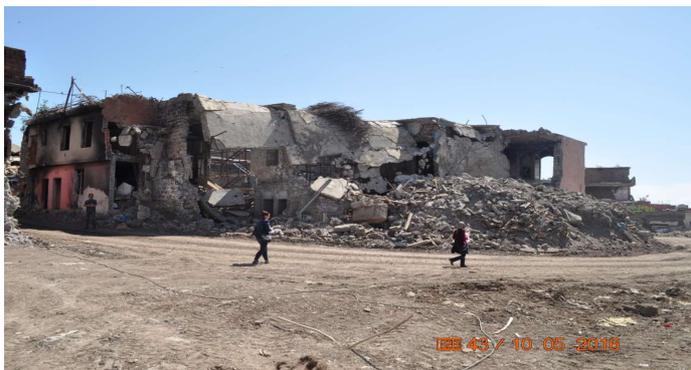
The *kabalti*, or *abbara* (a kind of arch), another example of registered civil architecture, projected to become the Mehmet Uzun Museum. Restoration process begun before the conflict was completely destroyed and the carrying system has been damaged.

Photo. 7: Mehmet Uzun House, after demolition. 10.05.2016

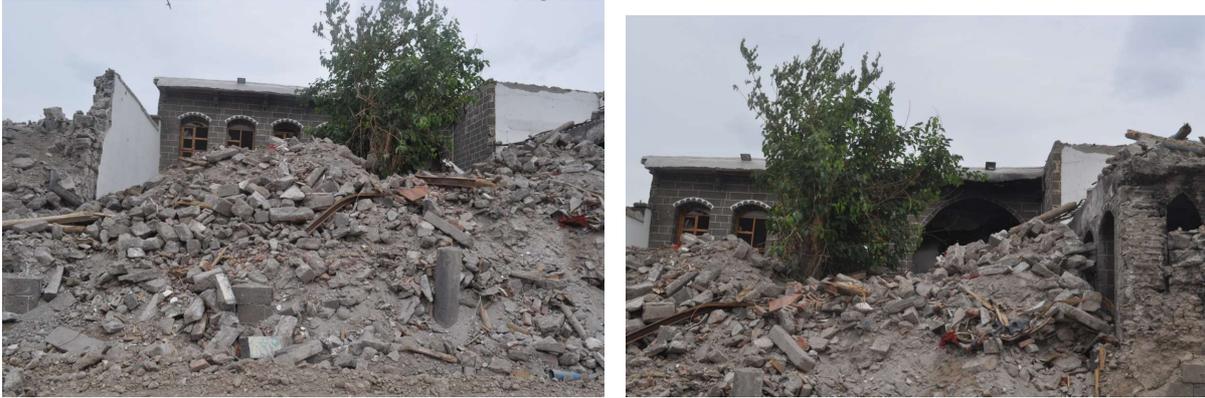
The southern part of the house has been demolished to widen the Yenikapi street.

Photo. 8: Appearance of the registered building belonging to the Chamber of Trade and Industry, May 2016.

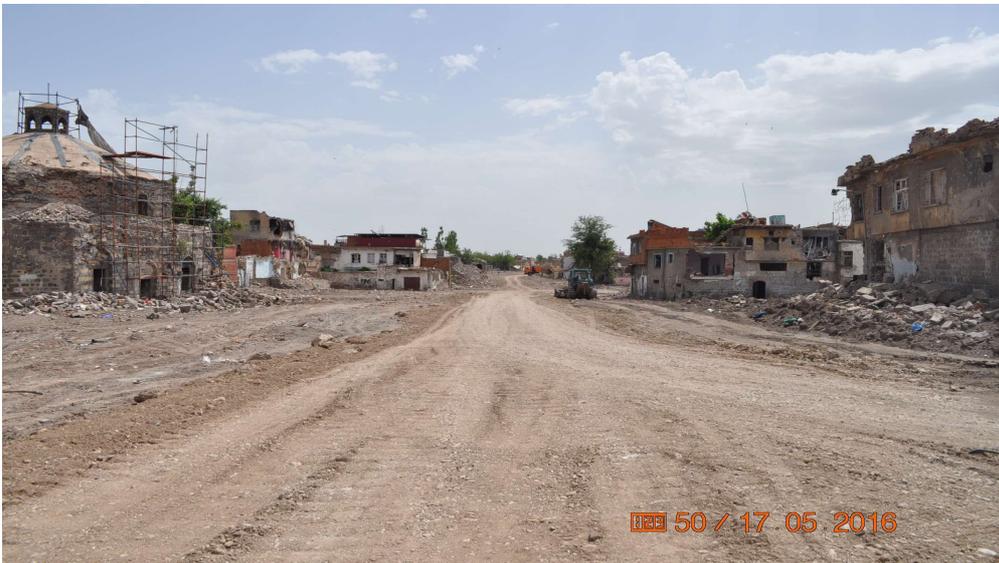
Photo. 9: The Yenikapi street, which kept its original width of 8m before the demolition, has been turned into a 15 m wide street.

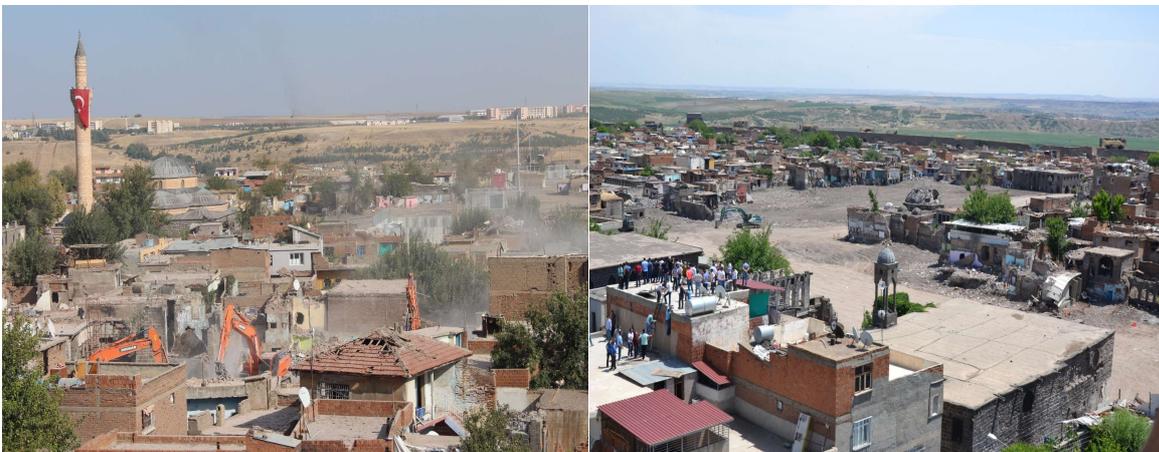
Photo. 10: The excavators on Yenikapi street.

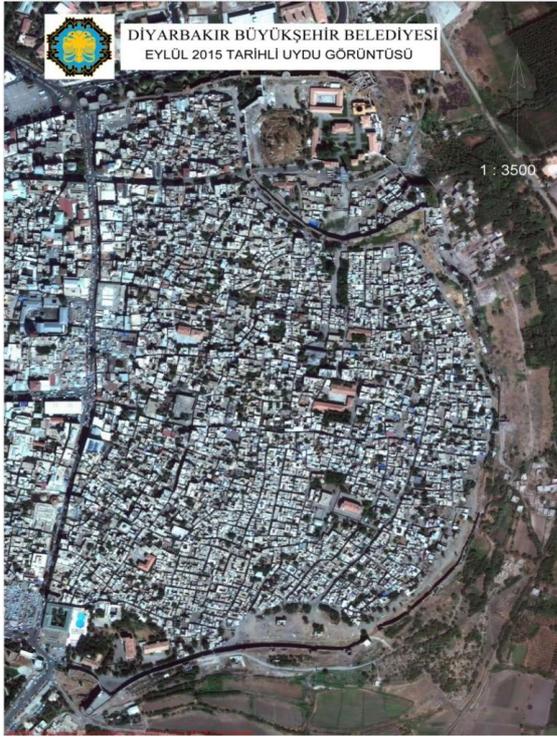
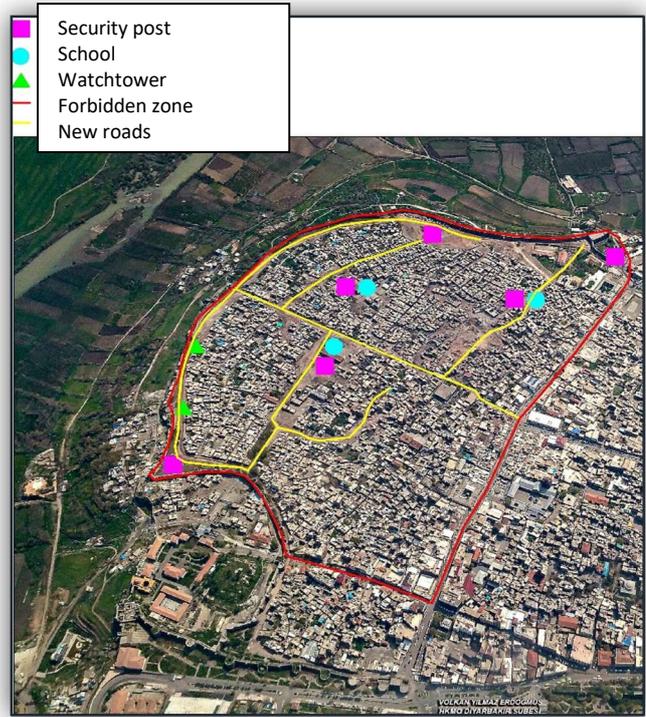
Photo. 12: 2015 Satellite image, before conflict **Photo. 13:** April 2016 view, commercial flight

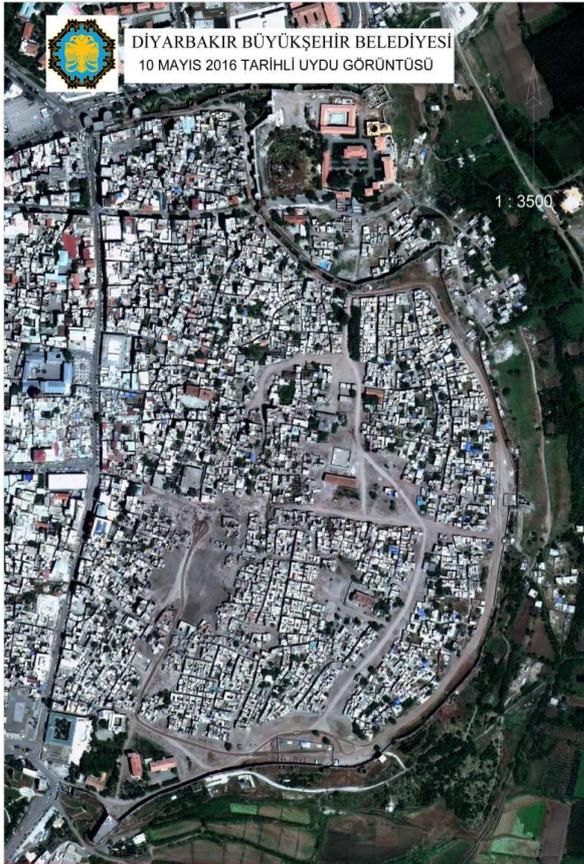
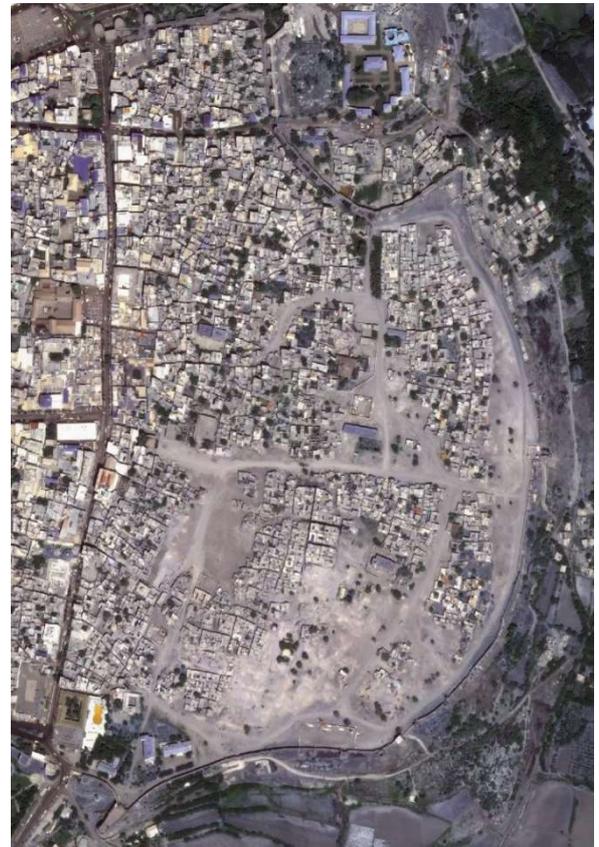
Photo. 14:Satellite image taken on 10 May 2016, **Photo. 17:** 16 August 2016 satellite image. after the termination of the operations.

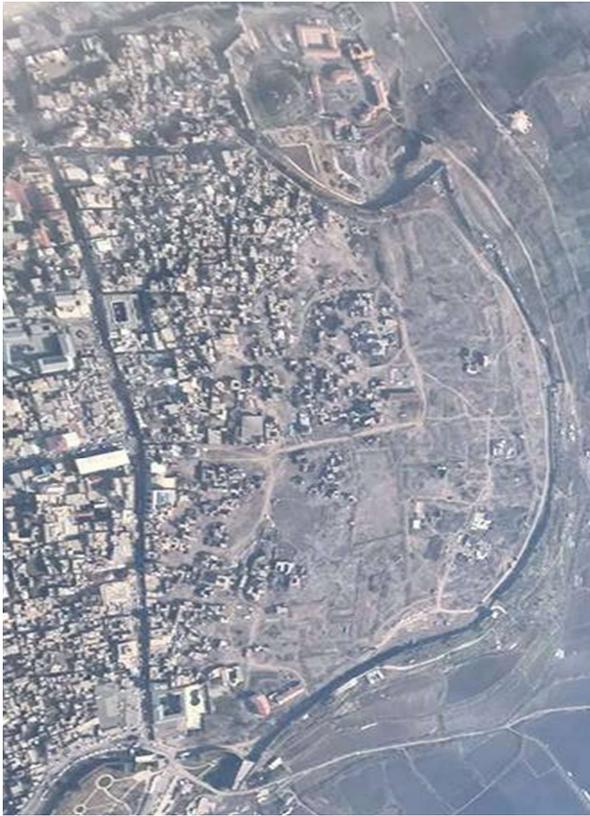
Photo. 18: 4 April 2017, picture taken from a commercial flight

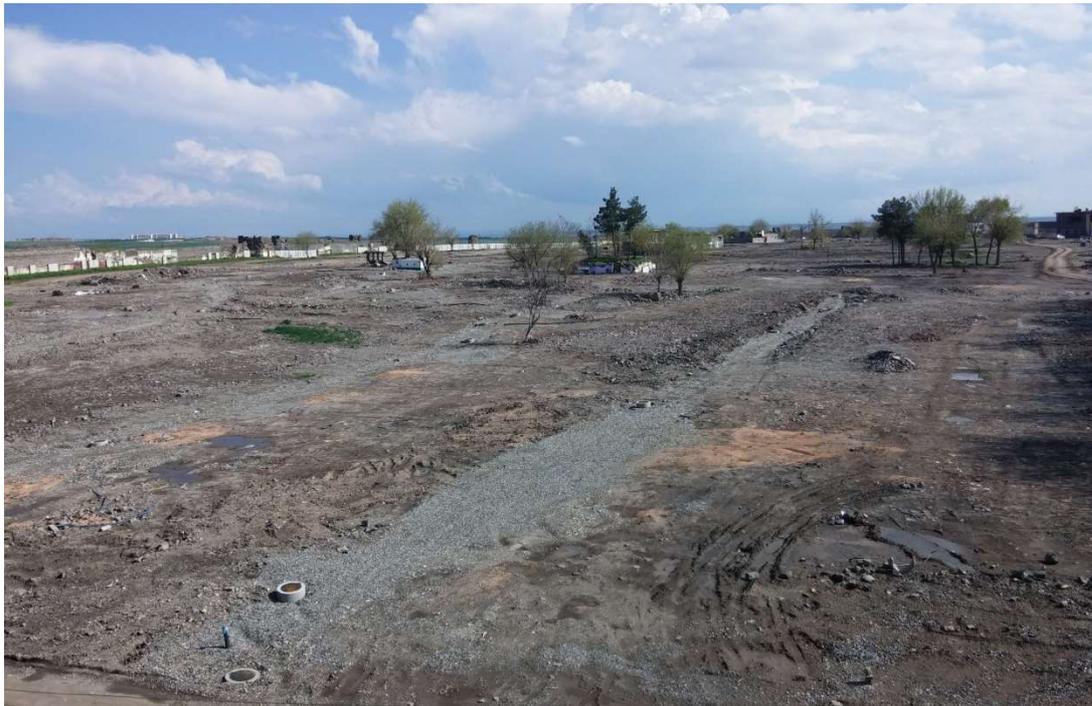
As a result of the demolition, which has been going on since February 2016, and is still going on as of the writing of this report (16 June 2016), the Sur District, buffer zone of the World Heritage Site and a Registered Urban Site has been turned into a bare flatland. (Photos. 18,19). It has been ascertained, up to July 2016 that 76 registered buildings have been torn down. Likewise, 89 buildings which were under conservation and recorded in the Conservation Plan revised in 2012, since they were part of the urban fabric, were torn down completely. It was observed that the street plan, which gave integrity to the city, as well as the outlines of the original parcelling have been completely obliterated.

Photo. 19: Inside the walled city, turned into a flatland, 19 April 2017.

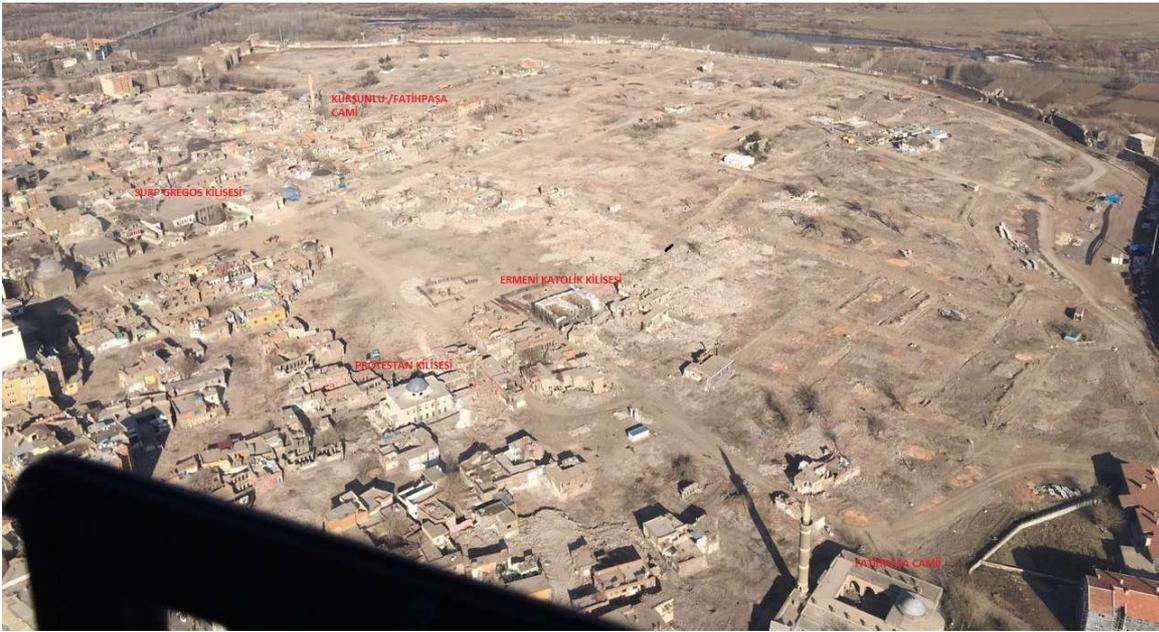
Photo. 20 : 4 May 2017 Aerial photograph.

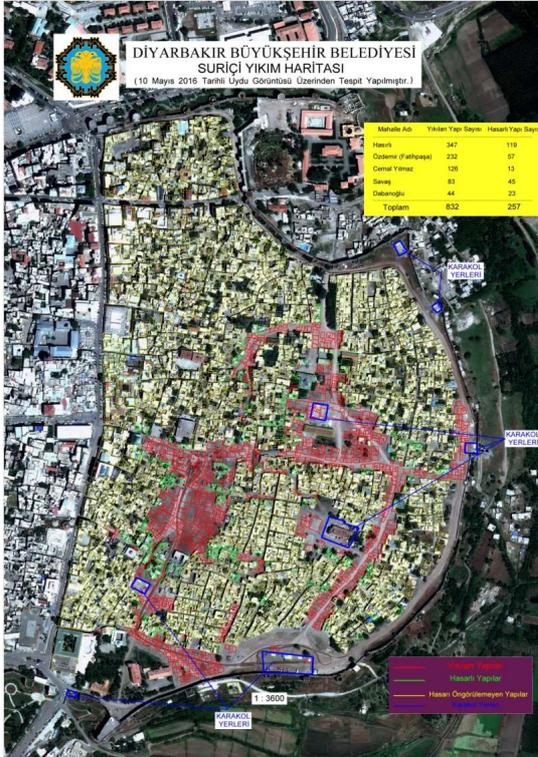
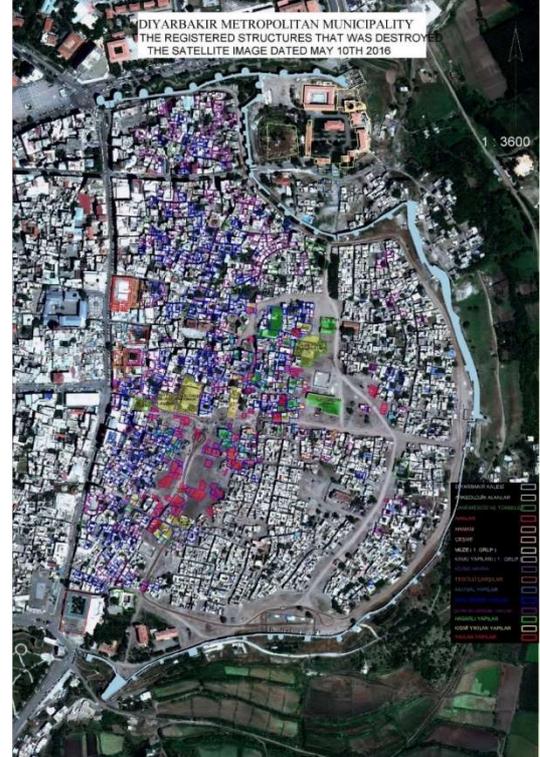
Total number of parcels of land in Sur is 7714. In the 6 blockaded neighbourhoods this number is 3646. The parcels pertaining to the demolished buildings were documented by superposing the cadastral maps on the satellite images. Satellite images from 10 May 2016 show that 10 hectares have been demolished, whereas in August 2016 the destruction covers 20 hectares. After the appointment of a caretaker administration to the greater Diyarbakir and also Sur municipalities, satellite images are not available but pictures were taken from commercial flights, during landing or take off. (Photos.13 - 20).

Map 2, 3 : (left) 10 May 2016 Sur demolition map, and (right) map showing the locations of registered or otherwise significant buildings which were demolished.

From the aerial and satellite images it has been determined in August 2016 that a total of **1519** structures have been destroyed completely, among them registered civil and monumental buildings. 89

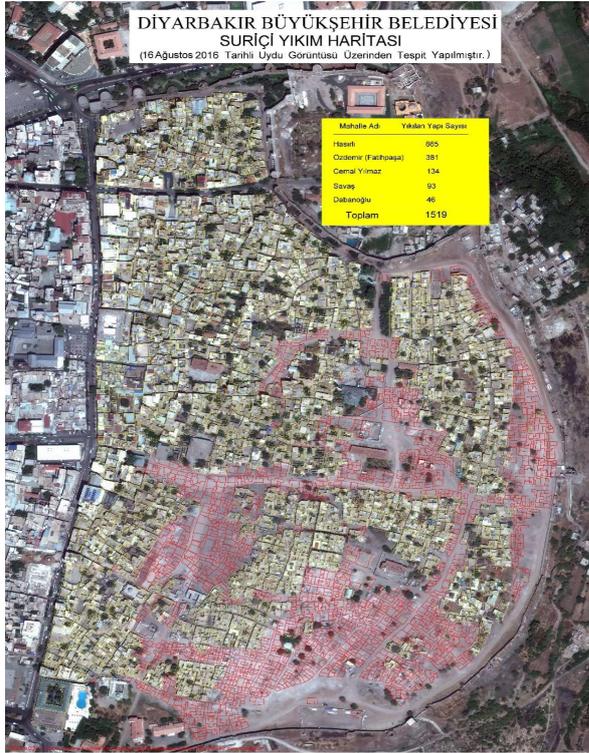
registered sites have been destroyed completely, 40 partially. 41 sites have only been damaged. Of these registered structures 76 are of civil, 13 of monumental and 81 marked as significant for the neighbourhood landscape. These numbers are growing every day.

Map 4 : Satellite image showing demolition. 16 August 2016, Sur.

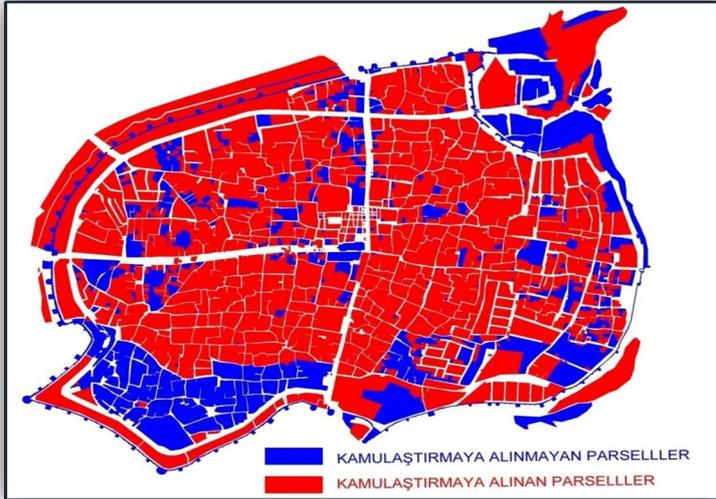
By this decision, 82% of the parcels in Sur will be requisitioned by the state. A large part of the remaining 18% is in the possession of the Housing Development Administration and the Treasury. As a result, Sur will be entirely passed into public ownership. This also means that the residents of these quarters will most probably not be able to return.

Map 5 : Map of the expropriation. Red indicates the parcels marked for expropriation. Blue indicates those parcels that are not included.

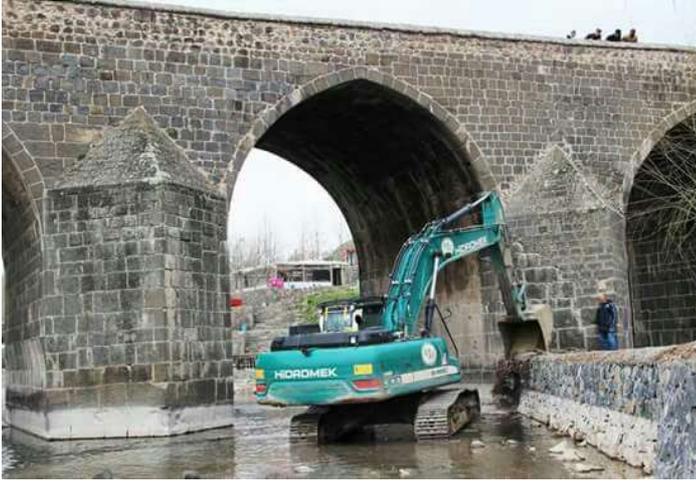
Nevertheless, in the aftermath of the demolitions and the requisitioning of the land, both the urban renewal project and the Tigris Valley Project were once more put into effect. The first stage of the Tigris Valley Project has started right next to the Bridge with Ten Arches (spanning the Tigris), which is right inside the World Heritage area. The Project includes the building of a mosque, a car park and restaurants.

Photo. 23 : Work being conducted on the Bridge with Ten Arches, part of the Diyarbakir World Heritage Cultural Landscape (26 March 2017).

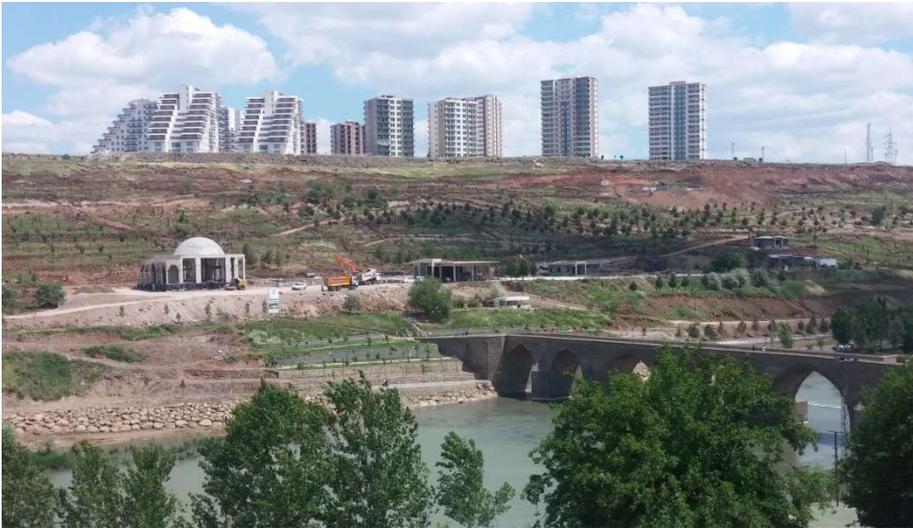
Photo. 24: Tigris Valley Project first stage (22 May 2017).

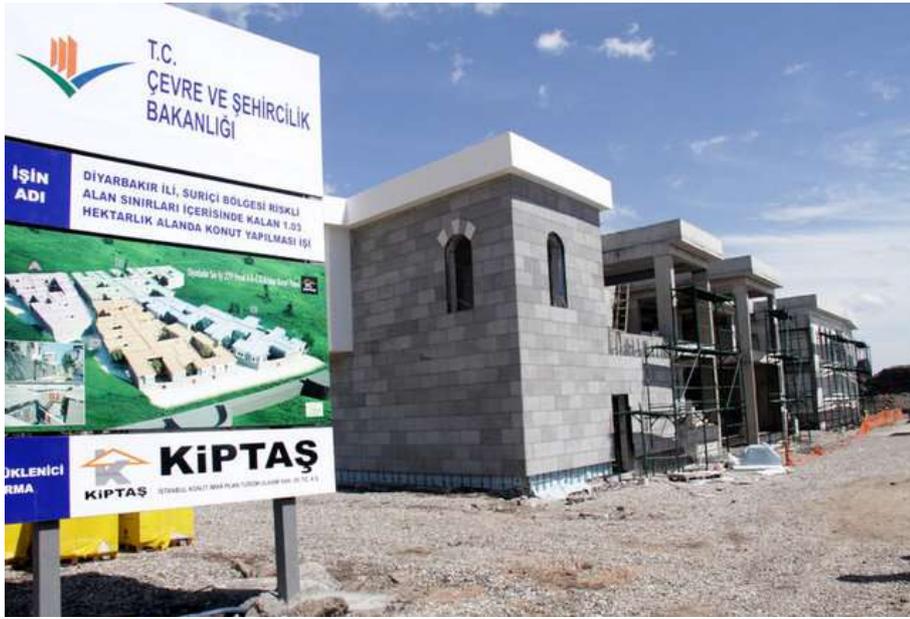
Reinforced concrete housing, which in complete dissonance with the historical city fabric and the traditional Diyarbakir houses, is being built in areas which have been razed and turned into construction lots. These houses clearly violate norms of the Urban Conservation Plan; the situation of the buildings, the dimensions of the courtyards and the walls do not respect the street and parcel proportions. Instead of basalt blocks, the traditional building material in the city, thin slabs of basalt are being used to dress the concrete walls. The exterior appearance of the buildings has nothing to do with the traditional street view of Diyarbakir. Moreover, the forced eviction of the inhabitants, the demolition of thousands of houses and the expropriation clearly indicate that the true owners of Sur will never be allowed to return to their homes again. But who, then, will be living in these new houses? It is obvious that the aim is to transform the political and demographic structure.

Photo. 25: New houses being built in Sur.

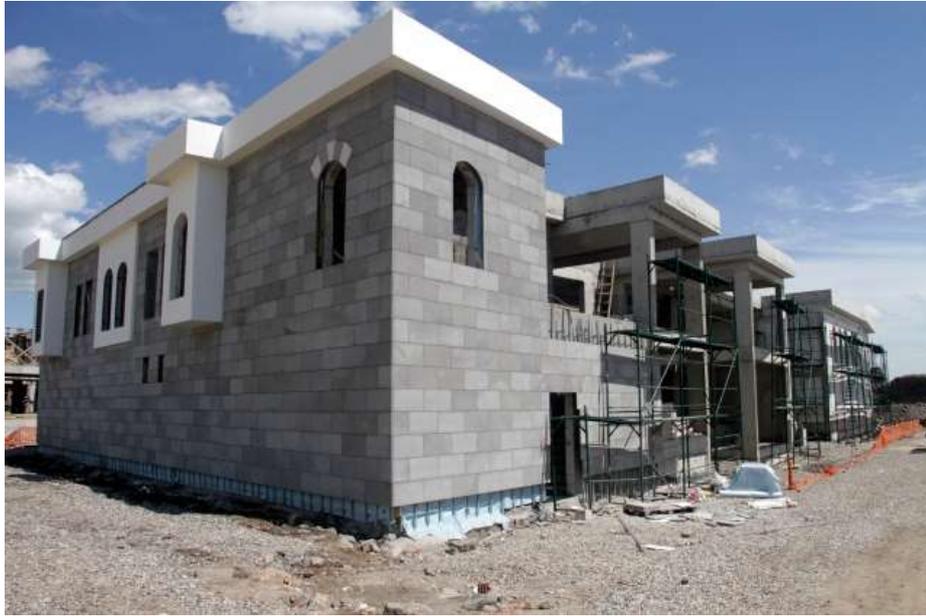
Photo. 26: In spite of the stipulation by the conservation Plan, that concrete houses with a deceptive thin stone facing are not to be allowed, the picture shows new reinforced concrete houses coated with basaltic slabs.

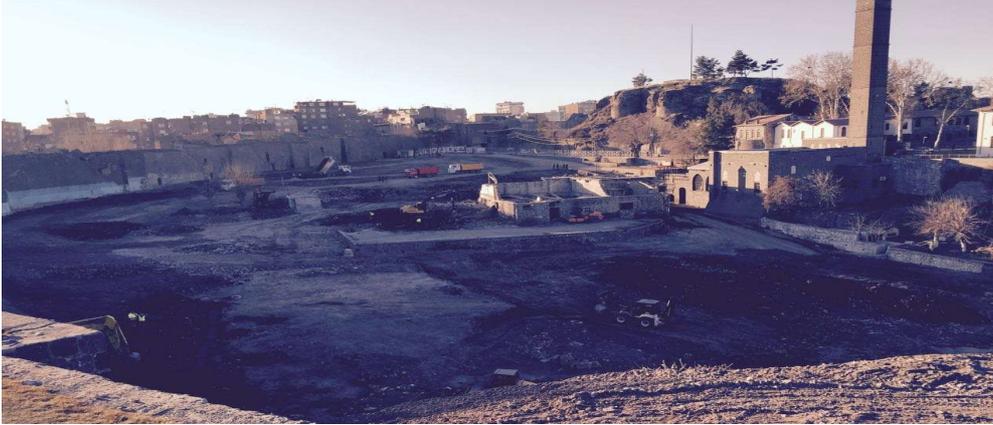
Photo. 27: View of the registered building still standing next to the Inner Fortress (Ickale) Mosque.

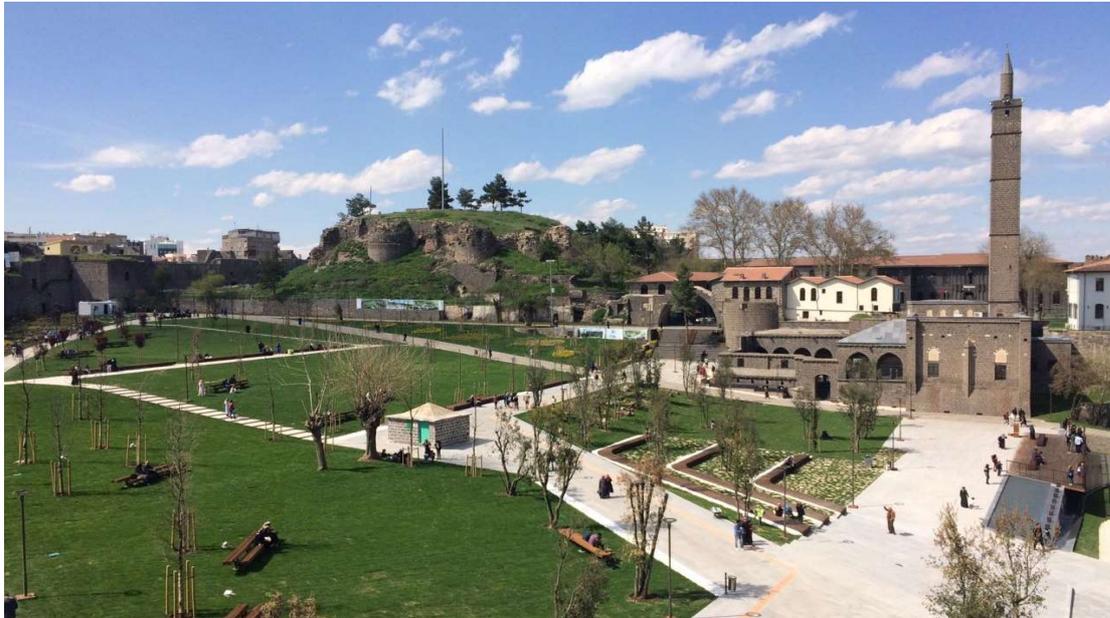
intended for the second stage has first been de-registered and then demolished, the cleared space has been designed as a modern park. Meanwhile heavy machinery have been used to excavate and level the are, and many trees with extensive roots have been planted. All of these interventions have a high probability of damaging the archaeological remains.

Photo. 28: The modern park in the Inner Fortress. The registered building next to the mosque (Photo. 27) has been torn down.
